DEPARTMENT OF TRANSPORTATION**DIVISION OF ENGINEERING SERVICES**

Quality Assurance and Source Inspection

Contract #: 04-0120F4Cty: SF/ALA Rte: 80 PM: 13.2/13.9File #: 1x.28**WELDING INSPECTION REPORT****Resident Engineer:**Pursell, Gary**Address:** 333 Burma Road**City:** Oakland, CA 94607**Report No:** WIR-012664**Date Inspected:** 17-Mar-2010**Project Name:** SAS Superstructure**OSM Arrival Time:** 700**Prime Contractor:** American Bridge/Fluor Enterprises, a JV**OSM Departure Time:** 1530**Contractor:** American Bridge/Fluor Enterprises, a JV**Location:** Job Site

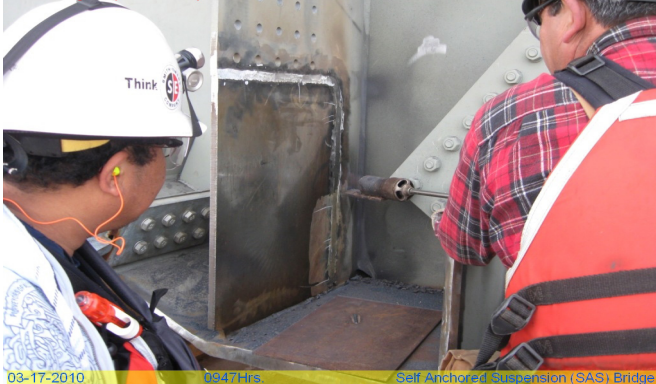
At Lift 2W longitudinal diaphragm line 3, CJP repair, welder John Rosas is seen preheating the plate prior welding the low spots/weld underfill. ABF QC Bonifacio Daquinag is also seen monitoring the preheat temperature.

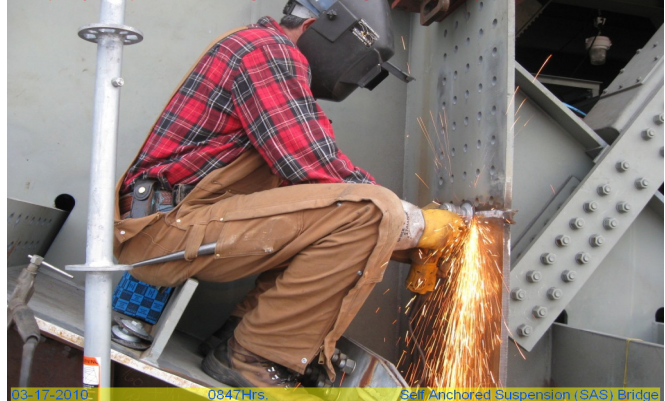
When all the underfills were welded, two ABF/JV welders, John Rosas and Al Mc Daniels were noted flush grinding the weld joints. After completing the flush grinding, QAI noted QC Inspector Bonifacio Daquinag Jr. performing visual inspection on the completely welded and flush ground weld joints. The QC inspector informed QAI that the weld repair was generally acceptable except that the bottom rat hole needs more grinding and some weld touch up on toe of the existing fillet weld due to excess grinding.

ABF/JV welder John Rosas flush grinding the weld reinforcement of the completed CJP splice joint repair at Lift 2W longitudinal diaphragm line 3, panel point 13.
